EXECUTIVE SUMMARY

ABSTRACT

INTRODUCTION

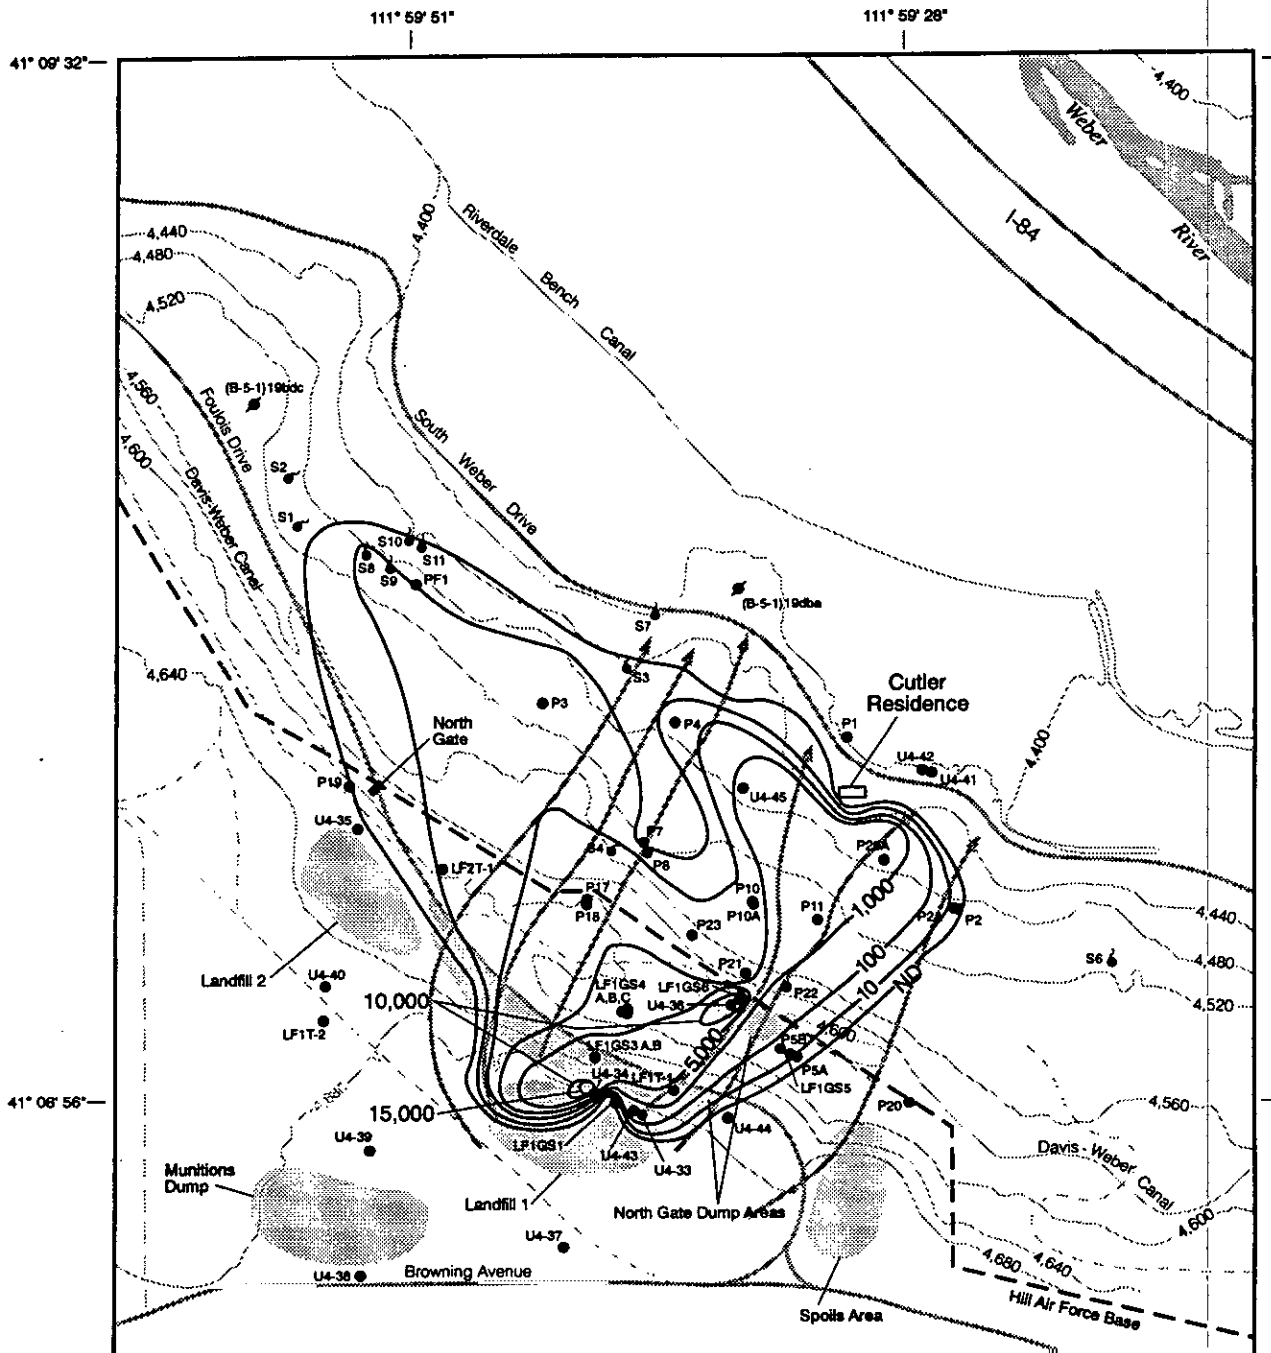
Figure ES-5.--Maximum concentrations of trichloroethylene in shallow ground water in the area of Operable Unit 4.

The most upgradient occurrence of TCE determined from chemical analyses of water occurred in water from wells U4-43 and U4-34, which are located along the downgradient edge (north side) of landfill 1 (fig. ES-5). Well U4-43 contained 440 ug/L and well U4-34 contained 18,000 ug/L of TCE. Because no TCE was detected upgradient from landfill 1 in well U4-37, the most probable source of TCE is landfill 1.

The largest concentration of TCE outside the Hill AFB boundary extends north from well LF1GS6. A tongue of the plume that contains between 1,000 and 5,000 $\mu\text{g/L}$ extended downgradient about 1,000 ft from well LF1GS6, to South Weber Drive. Inside the boundary of Hill AFB, the maximum concentration of TCE in ground water was 18,000 $\mu\text{g/L}$, and outside the boundary, the maximum was 2,800 $\mu\text{g/L}$. The contaminated area inside the boundary of Hill AFB is about 18.5 acres; outside the boundary it is about 44 acres.

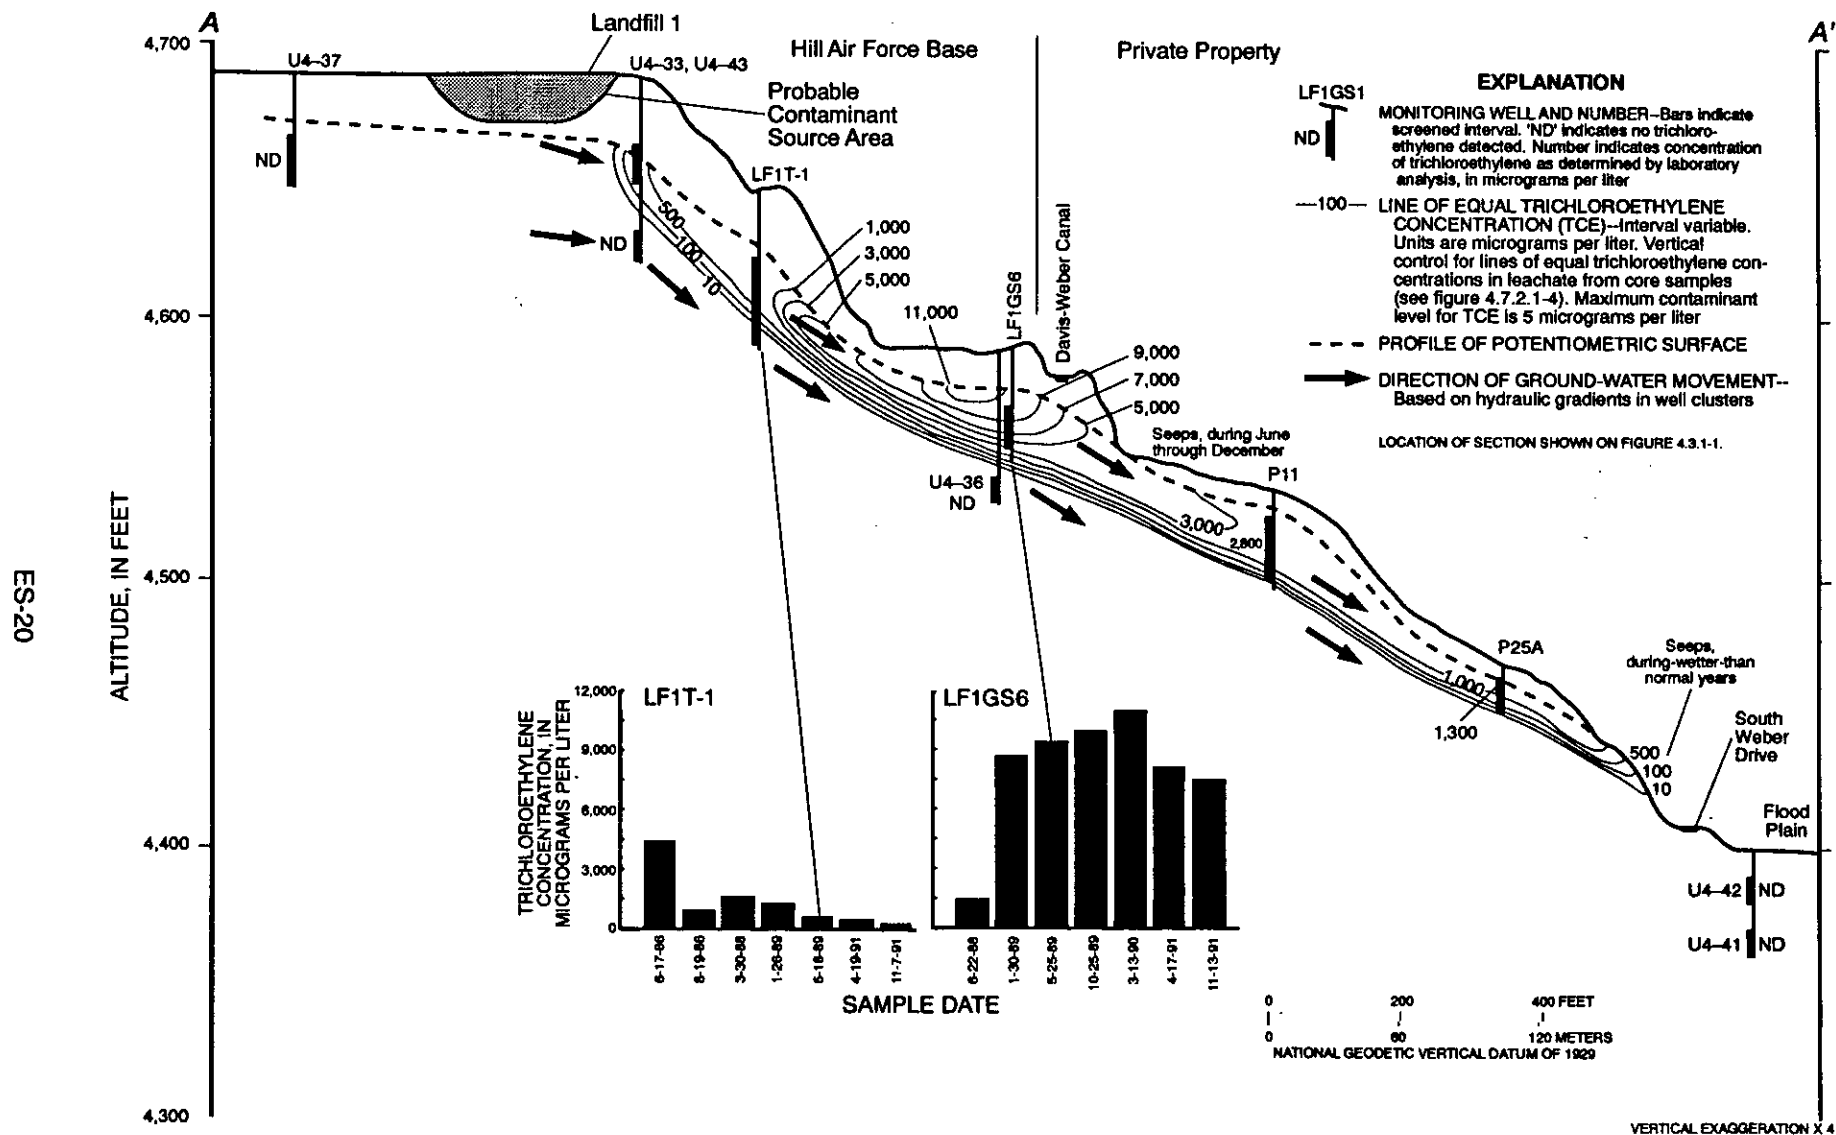
Figure ES-6.--Vertical, lateral, and temporal variations of trichloroethylene concentration in ground water along section A-A', 1986-92, in the area of Operable Unit 4.

Trends of TCE concentration with time may indicate that the plume is migrating past some of the wells downgradient from landfill 1. As indicated by the histograms in figure ES-6, the concentrations of TCE in water from well LF1GS6 peaked in 1990 and began to decrease in 1991. The concentration of TCE in water from well LF1T-1 generally has been decreasing since sampling began in 1986. The higher concentrations of TCE that probably occurred soon after disposal in landfill 1 apparently have been flushed from landfill 1 and migrated past well LF1T-1 prior to when sampling began in 1986, and then passed well LF1GS6 in 1990. If this interpretation is correct, the concentration of TCE in water from well U4-43 would be expected to decrease and the decreasing trends in well LF1T-1 and LF1GS6 would likely continue.

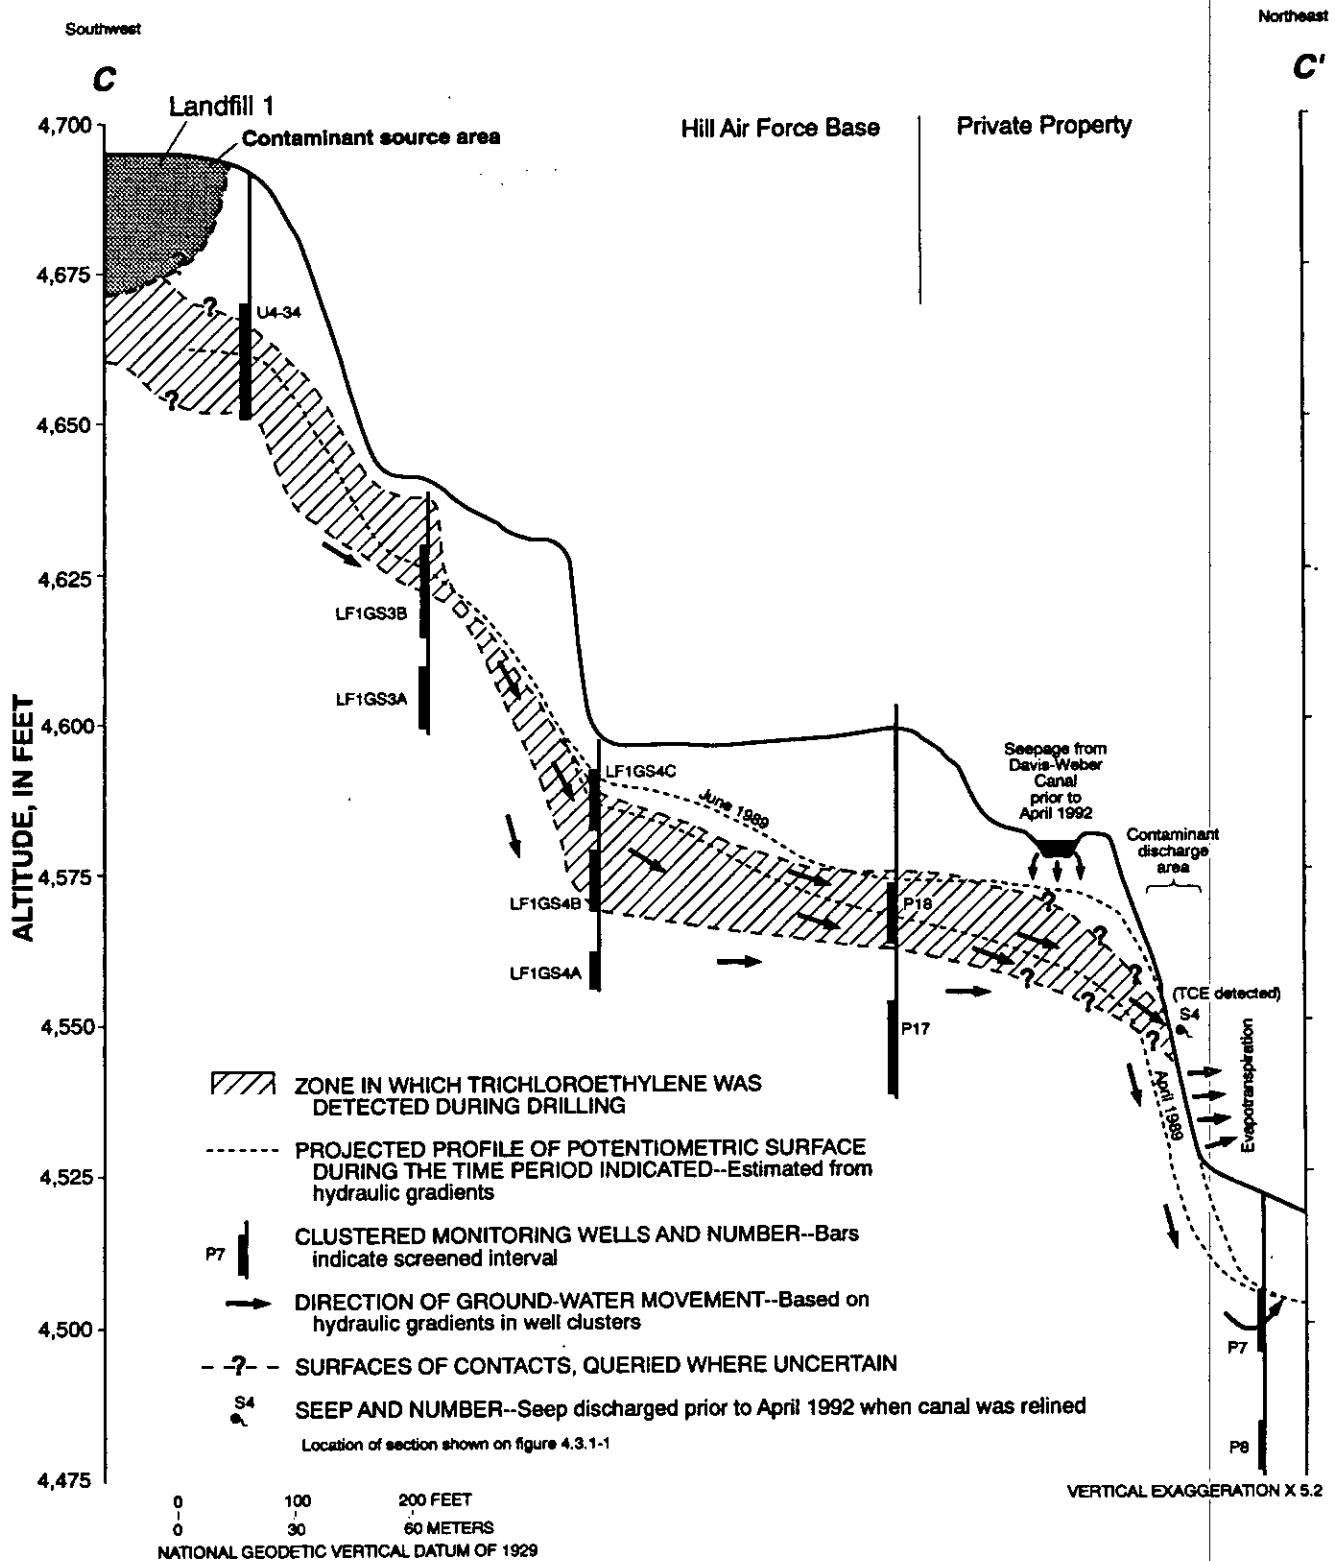
Figure ES-7.--Approximate movement of trichloroethylene along section C-C' from probable contaminant source to discharge location in the area of Operable Unit 4.

Hydraulic-head and chemical data from a well along the downgradient edge of landfill 1 and from clusters of wells at four sites downgradient from landfill 1 were used to construct an approximate flow path for contaminant migration (fig. ES-7). Along this approximate flow path, TCE apparently seeps from landfill 1 into the shallow ground water near site U4-34, migrates downgradient into the saturated zones of wells LF1GS3B, LF1GS4B, LF1GS4C, and P18, and discharges along the downgradient side of the canal bank at seep S4. Some ground water is lost by evapotranspiration along the bank, and TCE does not reach the cluster of wells, P7 and P8.
